## CASE STUDY

# PHC AND HEAVY METAL REMEDIATION IN NORTHERN BRITISH COLUMBIA

## BACKGROUND

**LOCATION:** NORTHERN BRITISH COLUMBIA

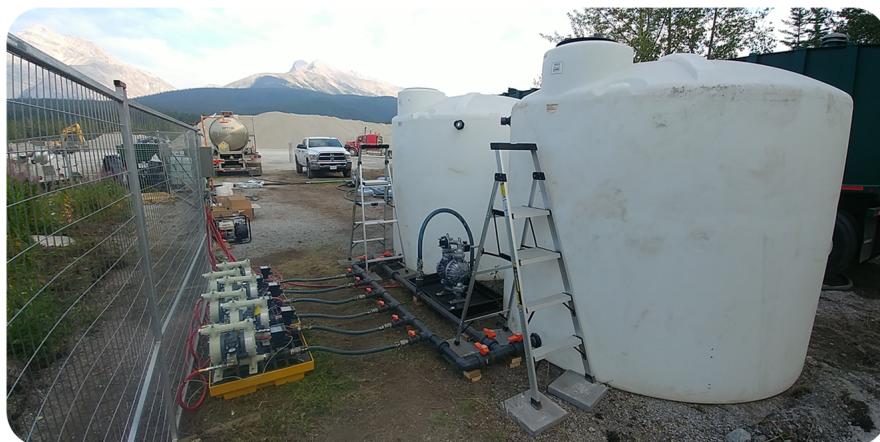
- The large scale of the plume necessitated the design of an injection system that could inject large volumes of solution while ensuring the reagents injected in each DPT point accurately reflected the remediation plan.
- A system was designed and then built on site that allowed for six direct push points to be injected simultaneously while allowing for the flow rate, injection pressure and total volume for each point to be controlled individually. With this system, IRSL was able to inject up to 110,000 litres of solution per day.

- 4.7 million litres of a 17.5% hydrogen peroxide solution was injected into 568 points using DPT to oxidize petroleum hydrocarbons in the target area.
- A small amount of citric acid and potassium citrate were added to the solution in order to act as a stabilizer and enhance the effectiveness of the hydrogen peroxide.
